# Woman Lake Action (WLA)

# What is a Rock Arch Rapids (RAR)?

# Discharge Measurements

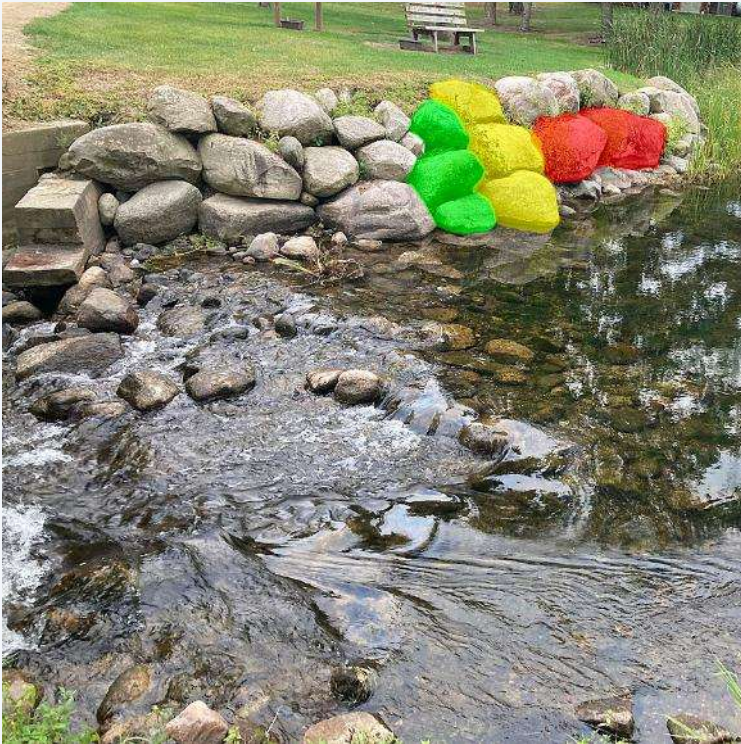
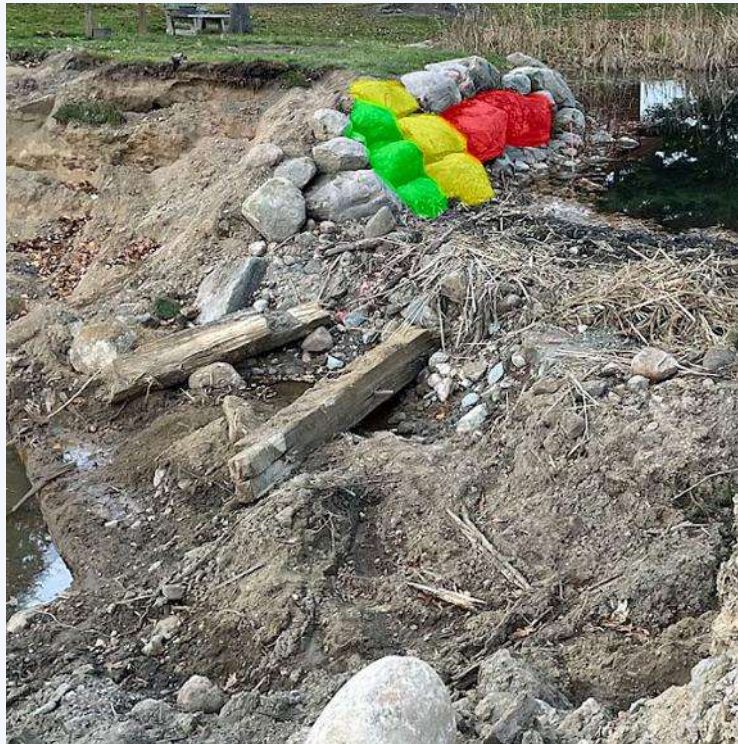
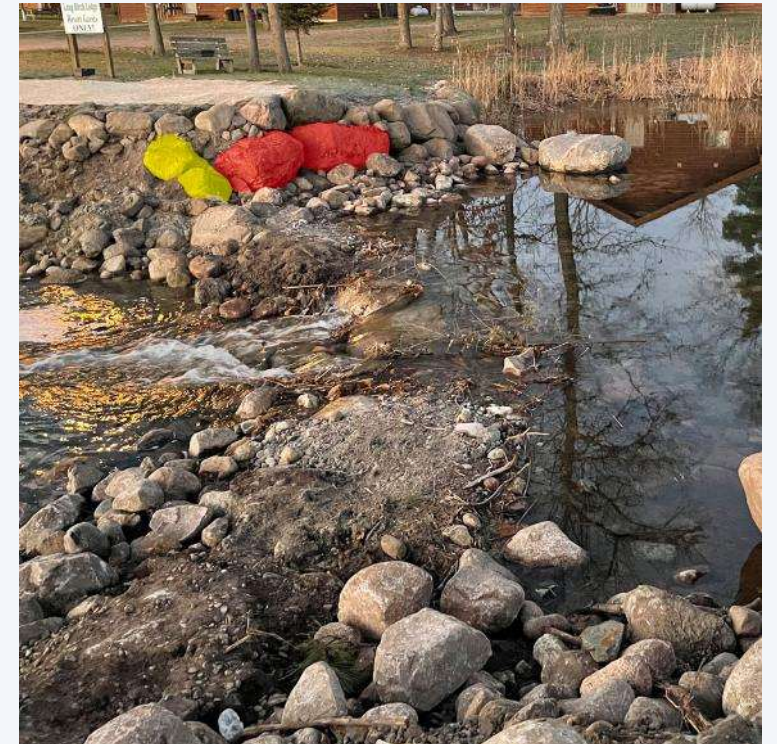
# Photo Record: Construction Phase Comparison

*Rock shading added to help orient a comparison between stages.*

Pre-Construction

During Construction

Post-Construction

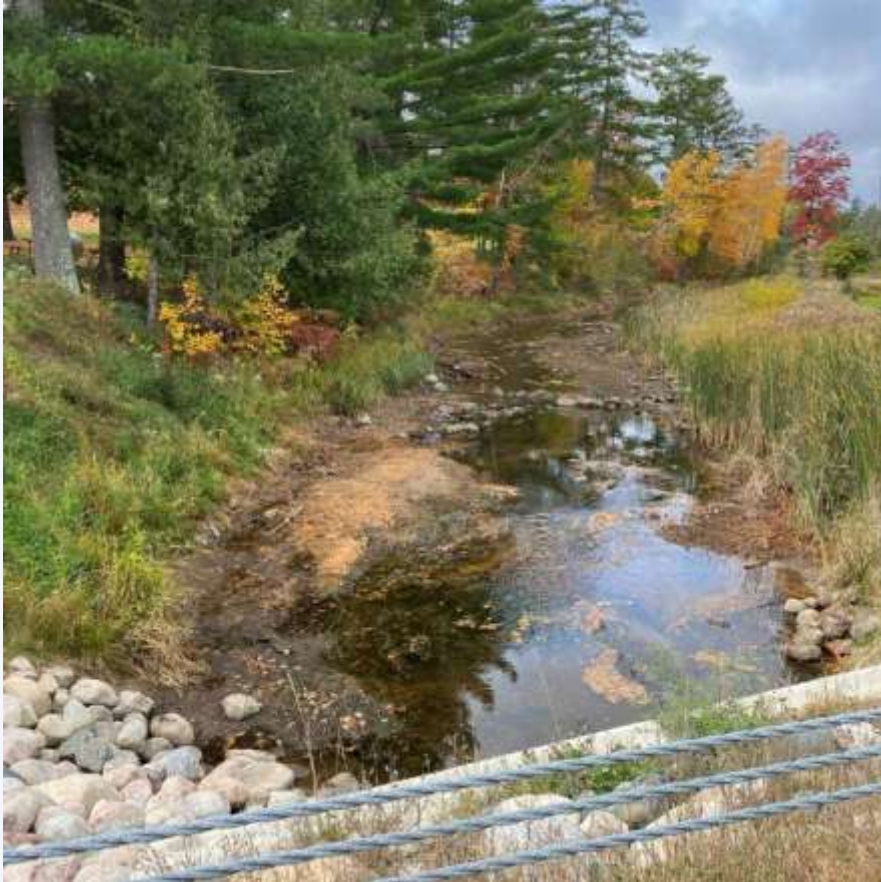
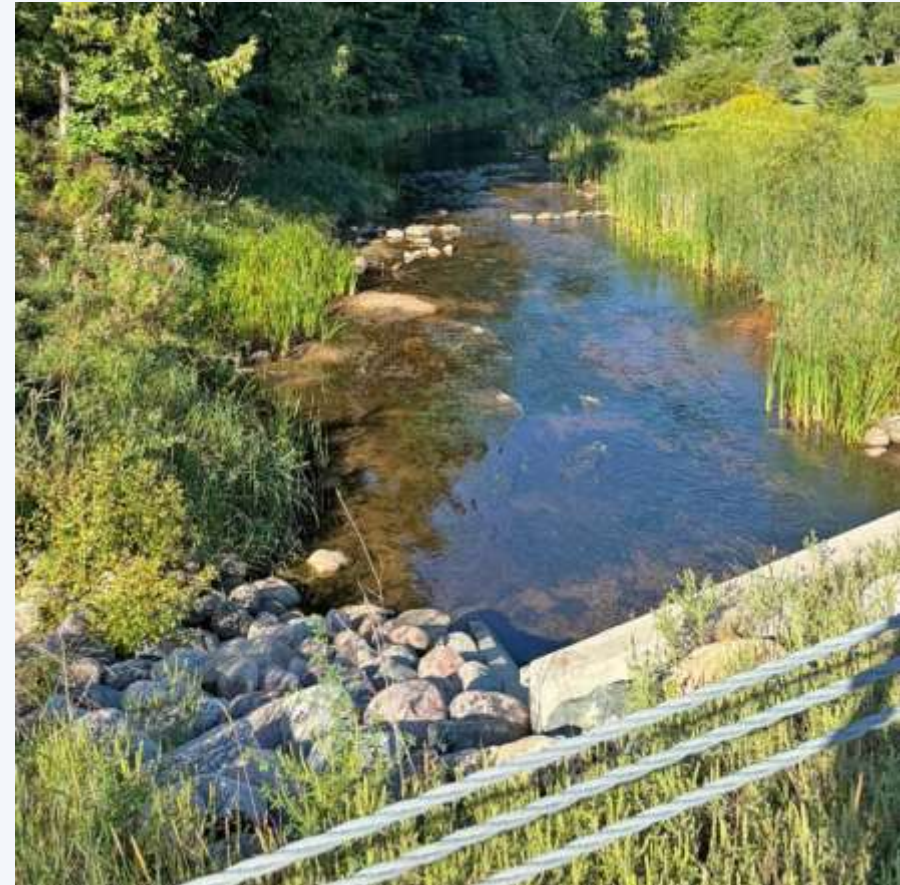
# Photo Record: Same Location, Different Years

**October 13, 2022**  
(**22.3** inches precipitation YTD  
Child Lake at **1323.50** on 8/13/22)

**September 1, 2026**  
(**15.5** inches precipitation YTD  
Child Lake at **1321.87** on 08/12/26)

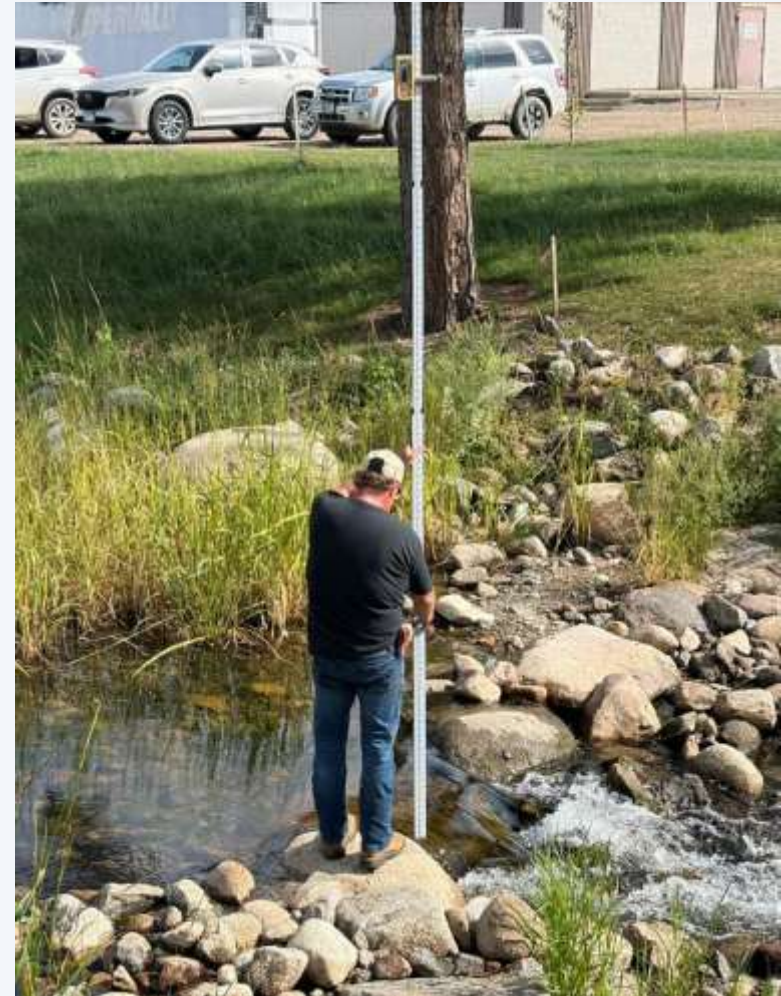
- Crest elevation appears consistent with the specified design elevation
- Openings between crest rocks appear to permit flow **below** top of nominal crest
- Subsurface or interstitial flow **through** the structure is a potential issue requiring engineering evaluation
- Our observations should be confirmed and integrated into independent review of former channel-and-dam control system
